# Slow-Controls Rack ORC

Slow control ORC (8/13/2021)

ORC version 1 was reviewed by Steve et al and provided following recommendations/modifications.

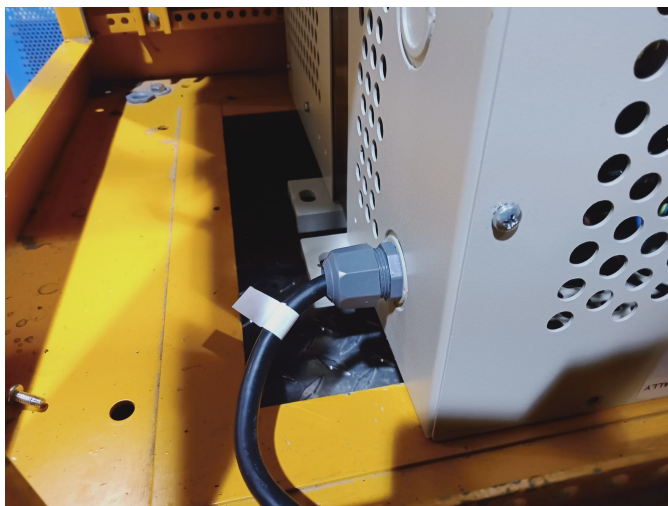
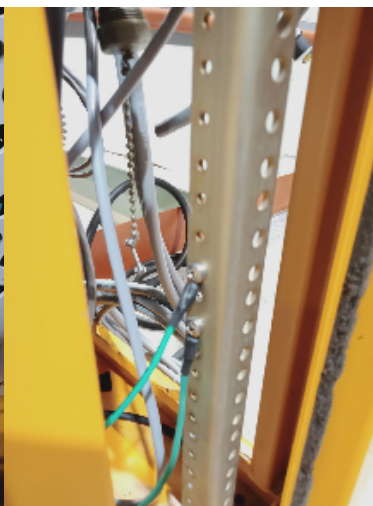
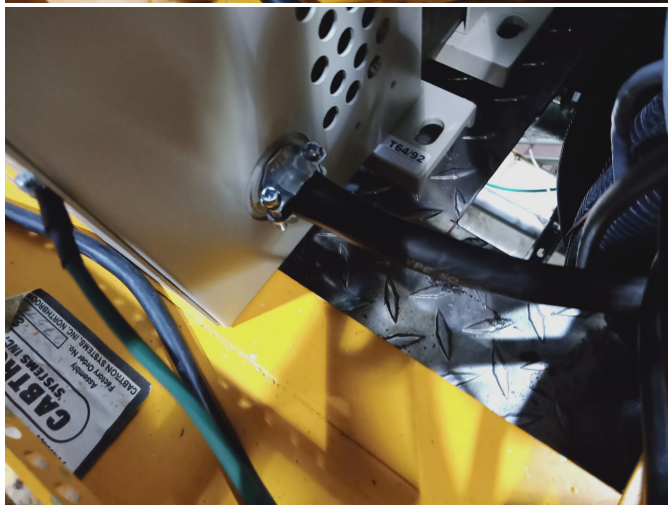
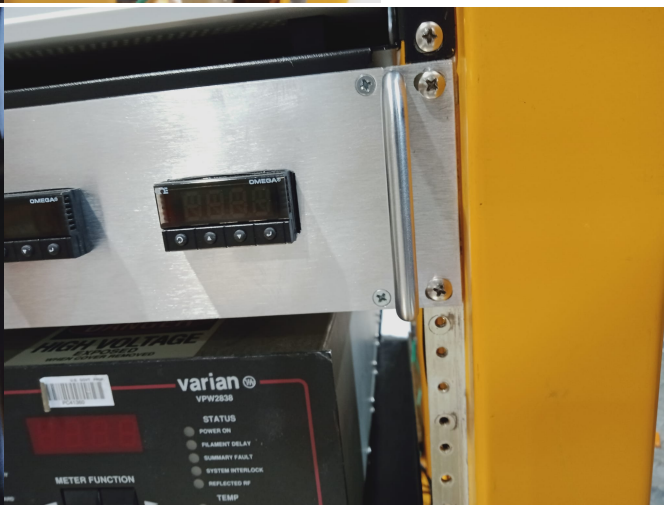
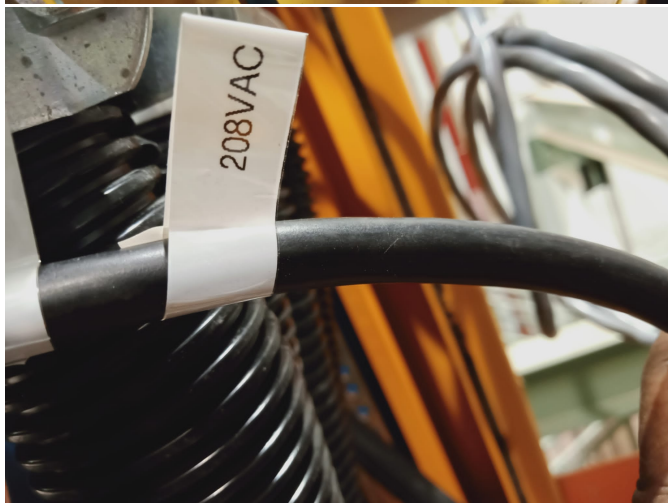
During the ORC review for this rack this afternoon, we found:

- 1) **Require** to install the lower screws for the Temp Interlock chassis front panel. Just using the top panel screw mounting holes puts a lot of stress on the front panel corners and the chassis is not firmly installed.

- 2) **Require** to label the isolation transformer AC output cord as being 208VAC on both ends. The IEC connector used on the equipment end of the cord is identical to those used for 120VAC,

- 3) **Require** to install the properly sized cable restraint glands or "cord grips" on the isolation transformer. These cords should not pull on the inside connections/conductors and the fittings for the glands need to be secured and tightened.

- 4) **Highly recommend** to provide some means of fixing the HV supply chassis from sliding on the shelf. It slid very easily when the cord was unplugged and then plugged back in.

- 5) **Require** to redress the AC cord coming from the AC 3-phase to single-phase distribution box. Cut the top cable tie and reroute the cord so it runs out of the rack (as discussed), to the receptacle, without sharp bends on the cord.

- 6) For the equipment safety ground wires, **require** to replace the fork-tongue terminals with ring-tongue terminals and add a star lock washer to the grounding connection. These terminals need to be properly crimped and solder cannot be used as the sole means of implementing the connection. There must be a mechanical restraint or method to secure the grounding connection.

All those recommendations/modifications were fixed and got the approval from Steve et al. Please see below few pictures after modifications.
