Thermocouple for Magnet Coil

Cryo Control Panel

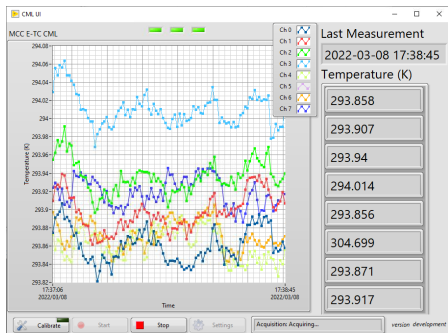
- ▷ VI on target computer
- ▷ “Ch. 5” (i.e. TC #6) is hidden from chart
- ▷ The others look normal

- ▶ The KF pipes were re-arranged — page 2
 - ▷ Ready to be vacuumed
- ▶ All the TC cables were connected with insulators and tags — page 3
 - ▷ Will be inspected by Steve Chappa during next ORC planned by Waqar
- ▶ Remaining issue:
Found that TC #6 (one of the bottom TCs) is disconnected inside
 - ▷ Do we plan to open the top side of the target dewar soon?
- ▶ Readout: MCC E-TC @ slow control rack

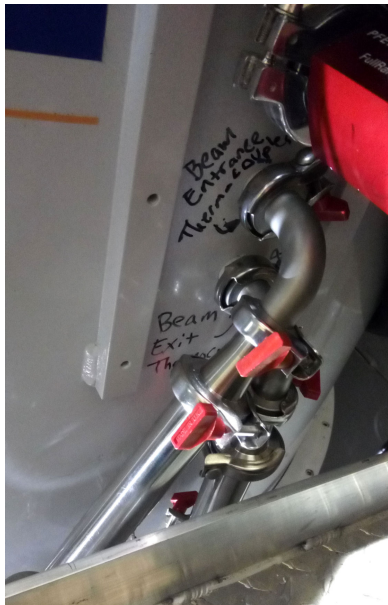
- ▶ The KF pipes were rearranged

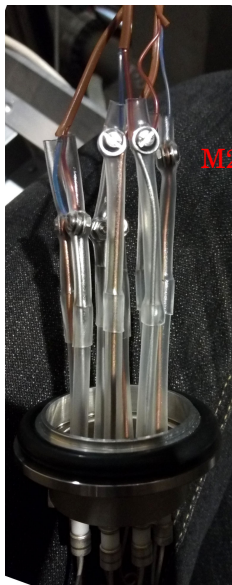
▶ TC cables were connected with insulators and tags

▷ Inside the feedthrough

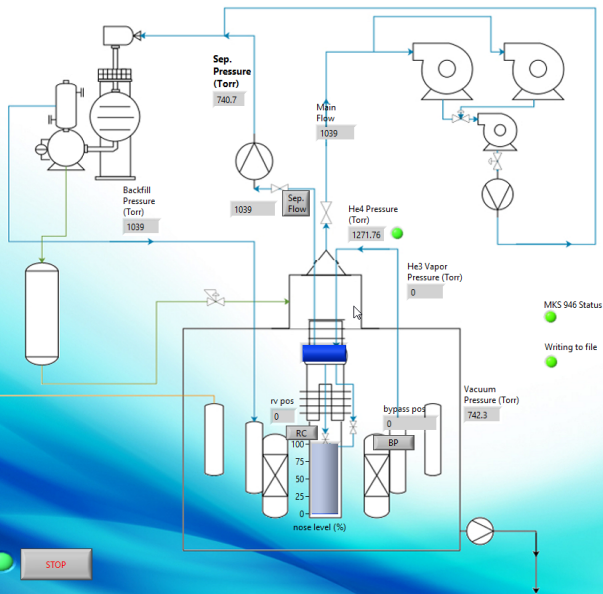
CryoControls

- ▷ Front panel — page 5
- ▷ Readings of MKS 722B and MKS 690 were activated
 - ▷▷ “740.7”, “742.3”, “1271.76” in page 5
 - ▷▷ Updated at 1 Hz
- ▷ Readings of obsolete devices were disabled and tagged with “1039”
 - ▷▷ To be replaced with new devices or deleted
